# THE IMPACT RESISTANCE OF CURRENT DESIGN COMPOSITE FAN BLADES TESTED UNDER SHORT-HAUL OPERATING CONDITIONS

## INTERIM REPORT

GENERAL ELECTRIC COMPANY  
Advanced Engineering and Technology  
Programs Department

1. Report No. NASA CR-134533	2. Government Accession No.	3. Recipient's Catalog No.	
4. Title and Subtitle "Impact Resistance of Current Design Composite Fan Blades Tested Under Short-Haul Operating Conditions"		5. Report Date July 1973

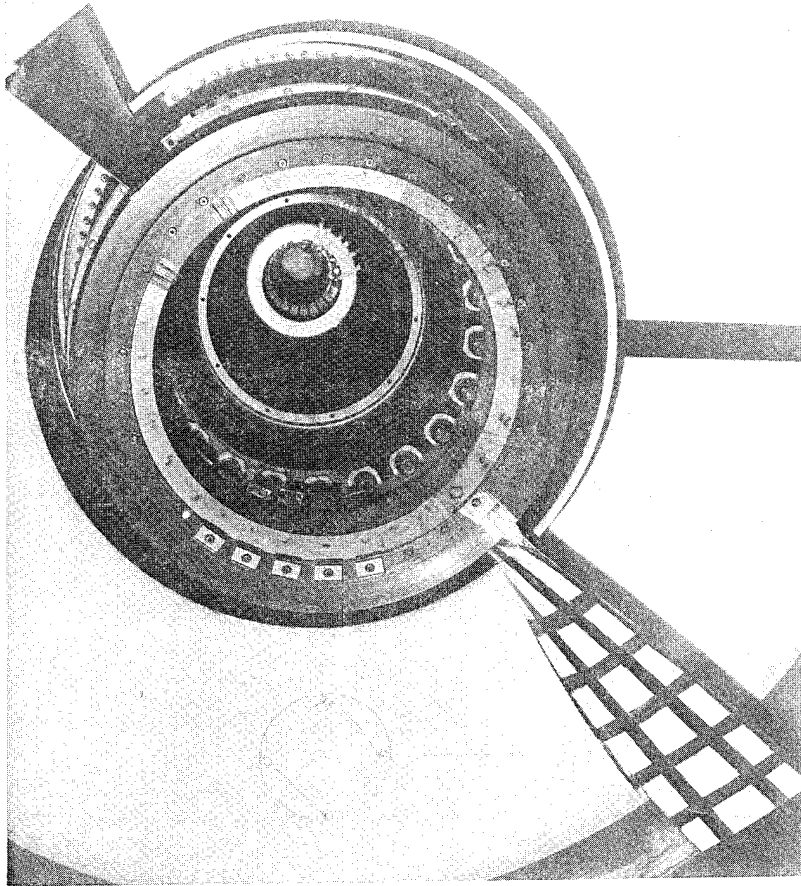
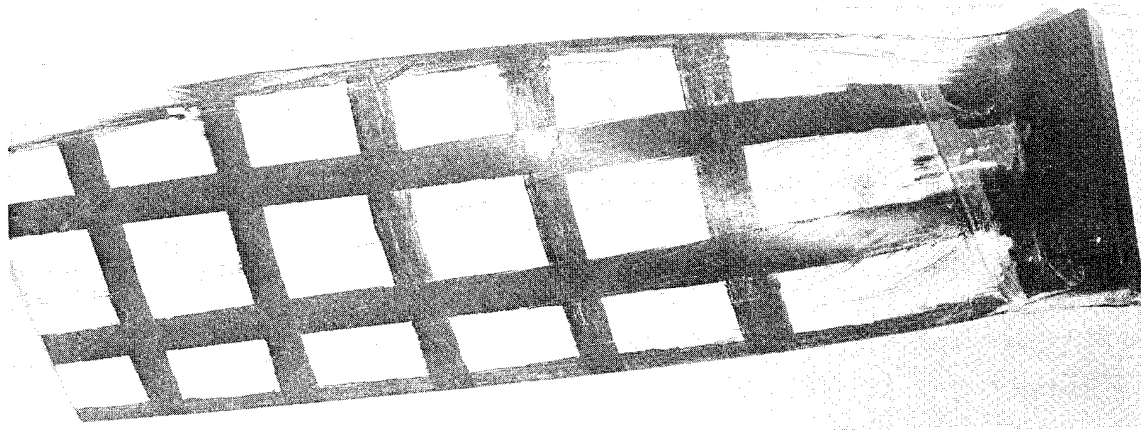
Figure 6. Blade S/N-NG1 after Impact.

Blade S/N	Bird Size	Bite Size	Damage*
NG1	12 Oz Simulated Bird	6 Oz	Loss of sliver and delamination at trailing edge of blade tip. Crack in dovetail.
NB2	12 Oz Simulated Bird	6 Oz	Radial crack in tip. Very small crack in dovetail at leading edge.
NG3	28 Oz Simulated Bird	12 Oz	Blade broke off at root.
NB4	28 Oz Simulated Bird	12 Oz	Blade broke off at root.
NG4	16 Oz Real Pigeon	11 Oz	Crack in root, as indicated by dye penetrant. Delamination in tip area.
NB3	16 Oz Real Pigeon	10 Oz	Delamination at base of leading edge, piece out of tip at leading edge. Delamination across tip.
Ti	16 Oz Real Pigeon	8 Oz	No damage.

NASA-FOD Impact Resistance Test  
 Blade S/N NG1  
 Graphite/Epoxy  
 Tip Speed: 800 ft/sec  
 12 oz RTV Bird  
 6 oz Slice  
 22° Incidence Angle

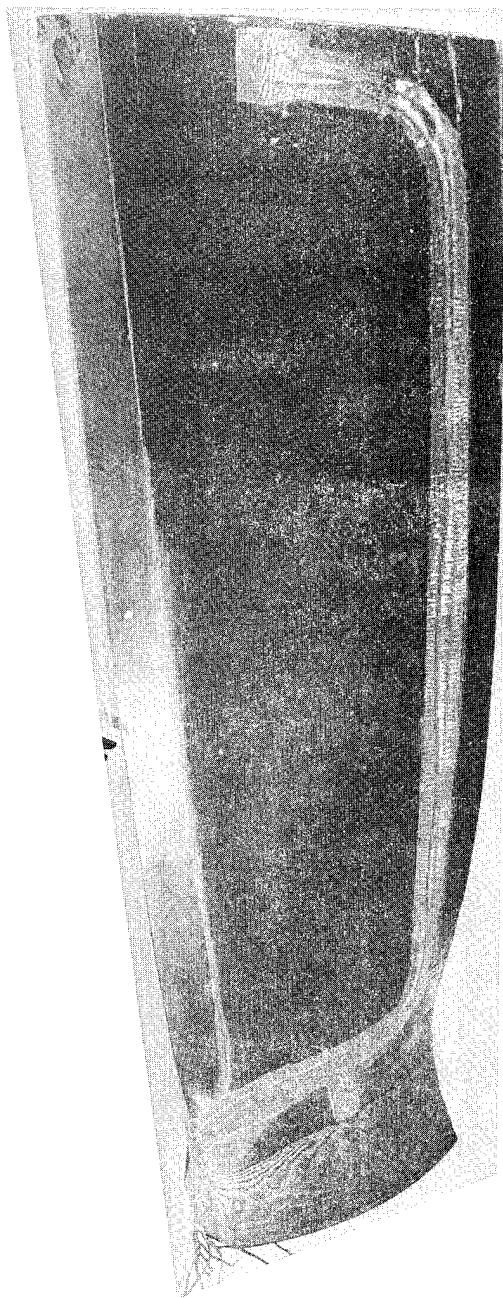
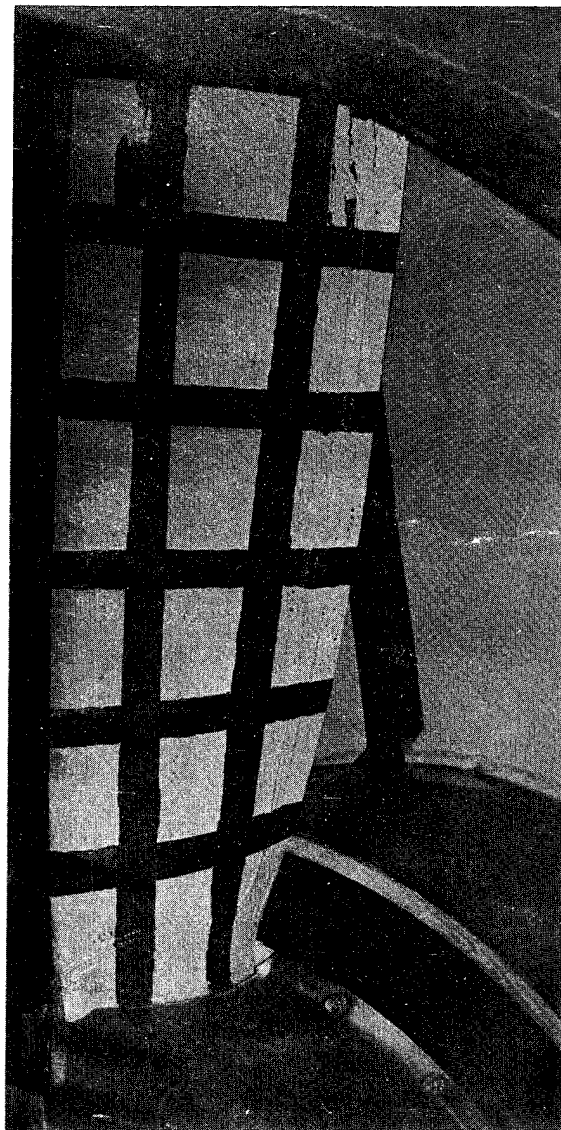
Figure 7. Blade S/N-NB2 after Impact.

NASA-FOD Impact Resistance Test  
Blade S/N NB2  
Boron/Epoxy  
Tip Speed: 800 ft/sec  
12 oz RTV Bird  
6 oz Slice  
22° Incidence Angle

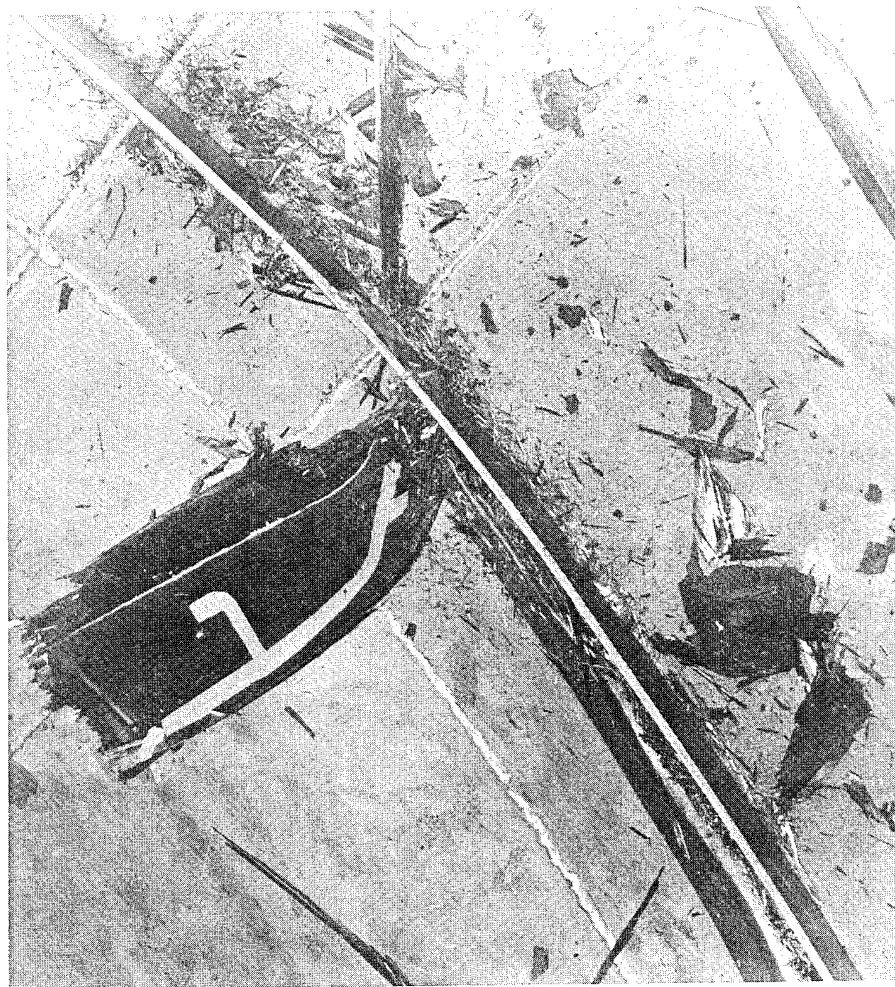
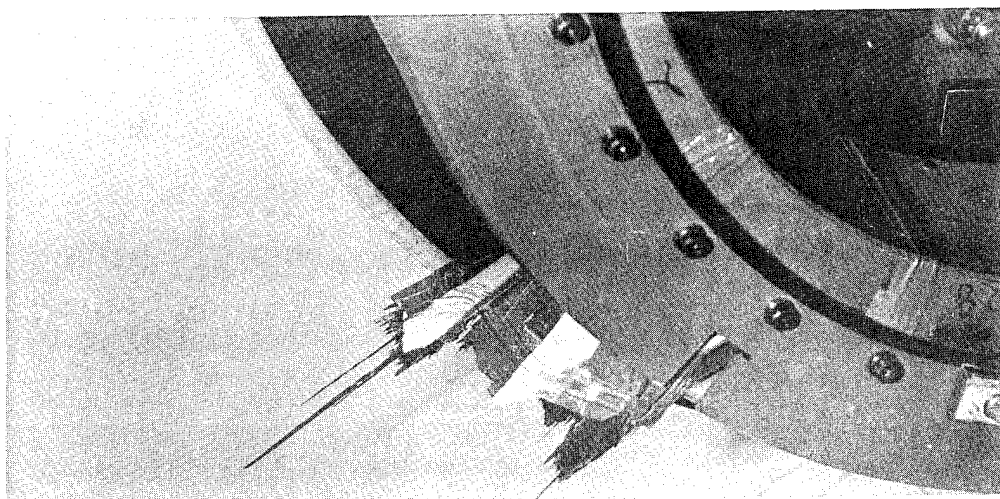
Figure 8. Blade S/N-NG3 after Impact.

NASA-FOD Impact Resistance Test  
 Blade S/N NG3  
 Graphite/Epoxy  
 Tip Speed: 800 ft/sec  
 26 oz RTV Bird  
 12 oz Slice  
 22° Incidence Angle

Blade S/N NG3 12 Oz RTV	No NDT evaluation--too severely damaged.
Blade S/N NG2 Gravel, Ice Balls	No visible damage. TTUCS* indicated small debonded area along leading edge (LE) protection. Remaining airfoil undamaged. Dye penetrant inspection did not reveal any cracks or delaminations in the dovetail (D/T) after impact. Velocity measurements confirmed TTUCS data. No loss in velocity was noted as a result of impact.
Blade S/N NG4 11 Oz Pigeon	Visible damage - Splintered at the trailing edge (TE) tip; severe root damage. TTUCS shows large delamination area running from D/T to midway up the blade. Tip badly delaminated also. Dye penetrant inspection showed delamination crack running around entire D/T. Velocity measurements show reduced values over entire blade section after impact indicating internal damage.
Blade S/N NG1 6 Oz RTV	Visible damage - Piece missing from TE tip; crack in D/T slight separation of nickel from LE. TTUCS reveals delamination area at base plus damage at TE tip. Delamination in D/T can be seen in photos of dye penetrant check. Low velocity measurements were recorded at the base of the blade, trailing edge side, indicating internal damage. A decrease in velocity readings after impact was also observed in the tip region indicating some damage.

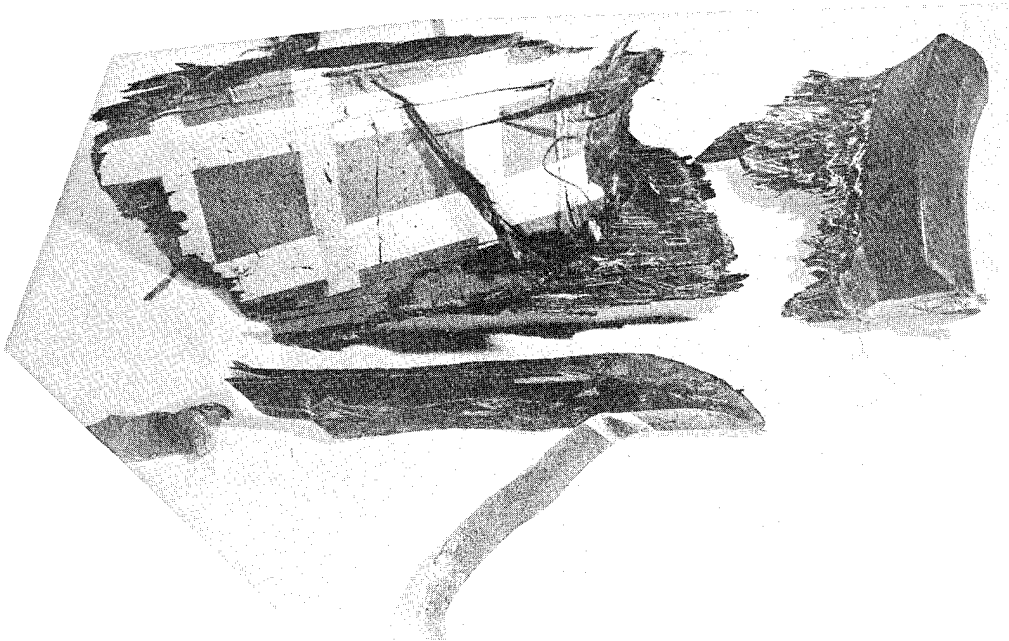
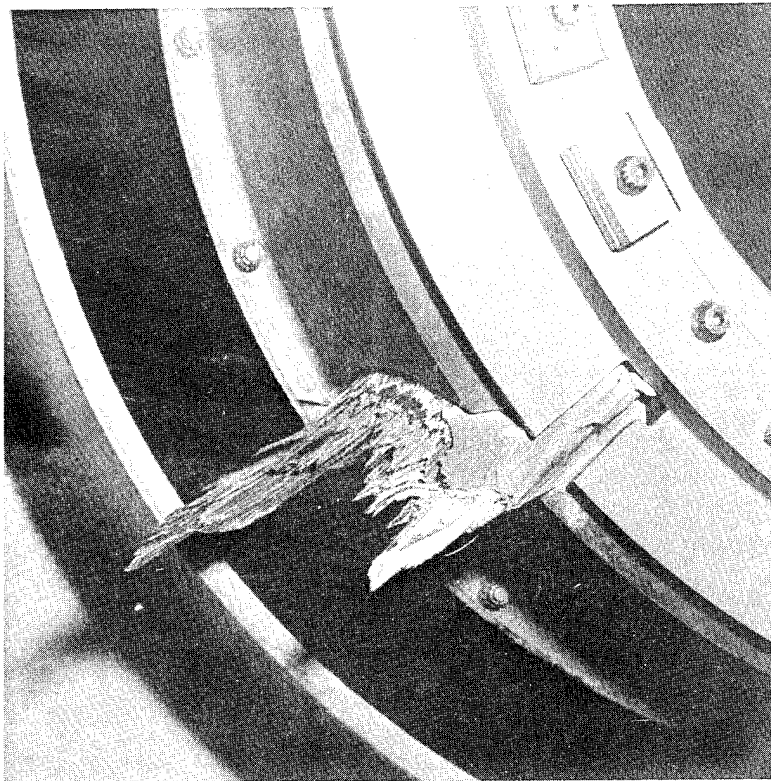
Figure 9. Blade S/N-NB4 after Impact.

NASA-FOD Impact Resistance Test  
Blade S/N NB4  
Boron/Epoxy  
Tip Speed: 800 ft/sec  
26 oz RTV Bird  
12 oz Slice  
22° Incidence Angle

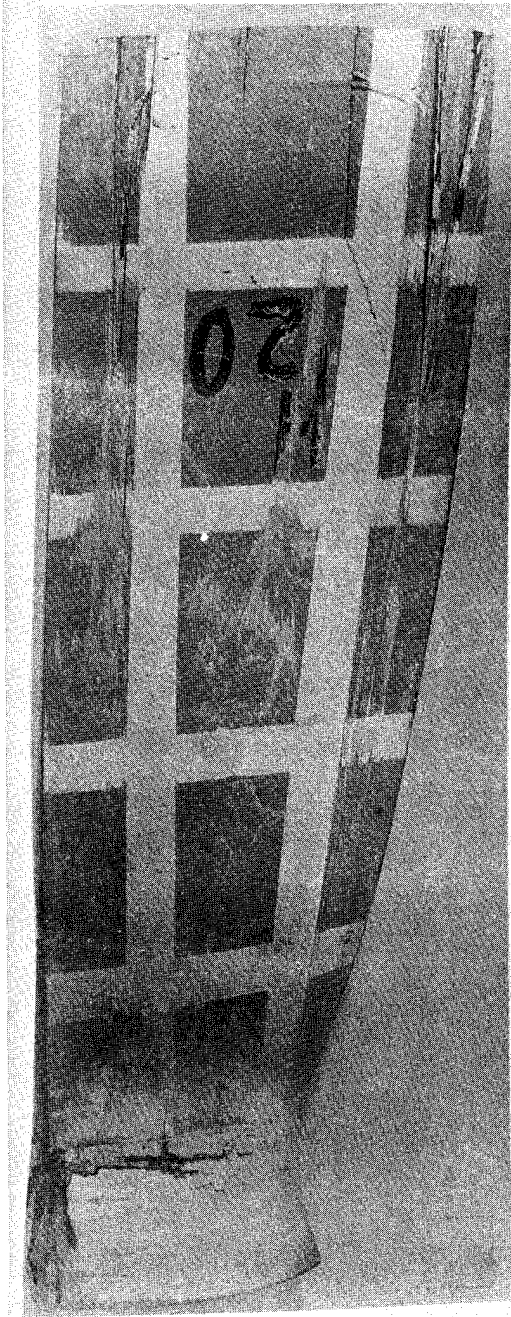
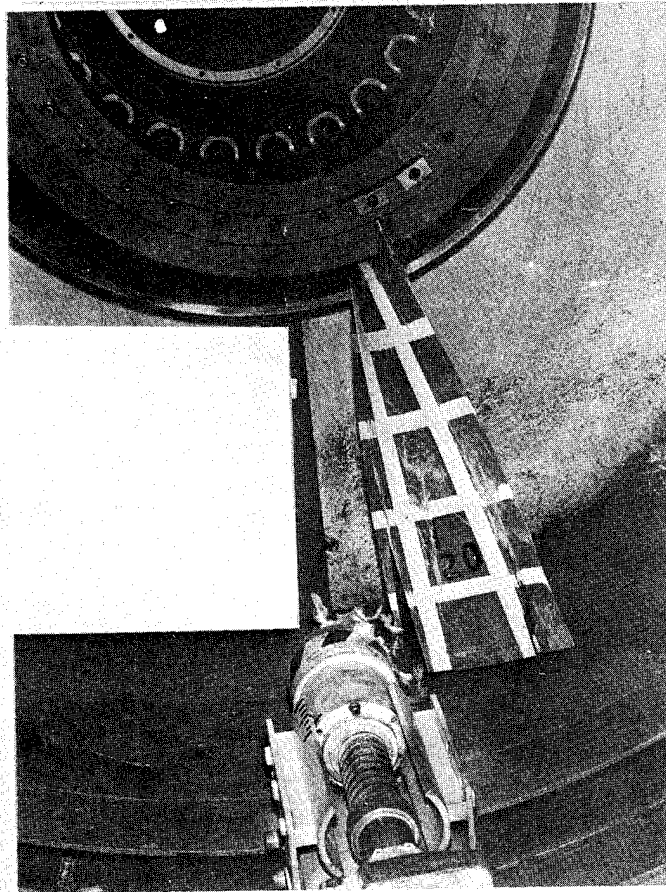
Figure 10. Blade S/N-NG4 after Impact.

NASA-FOD Impact Resistance Test  
Blade S/N NG4  
Graphite/Epoxy  
Tip Speed: 800 ft/sec  
16 oz Real Pigeon  
11 oz Slice  
22° Incidence Angle

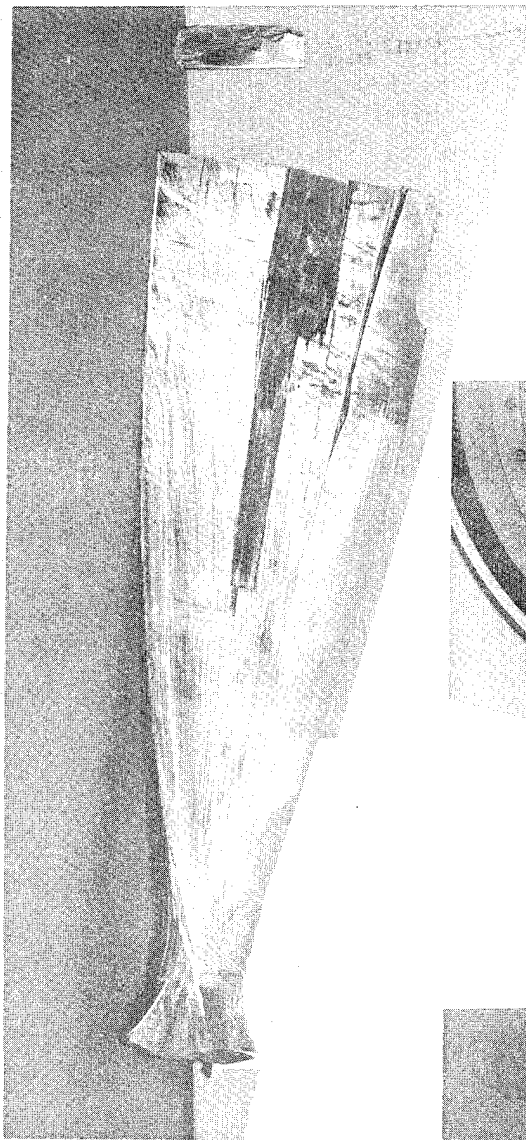
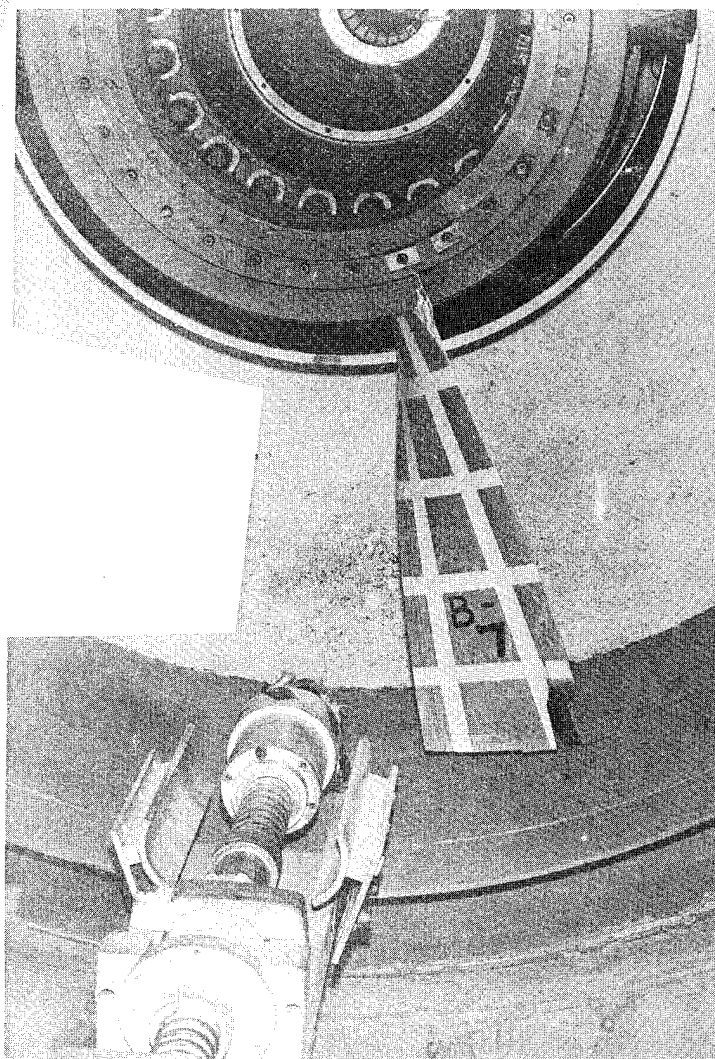
Figure 11. Blade S/N-NB3 after Impact.

NASA-FOD Impact Resistance Test  
Blade S/N NB3  
Boron/Epoxy  
Tip Speed: 800 ft/sec  
16 oz Real Pigeon  
10 oz Slice  
22° Incidence Angle

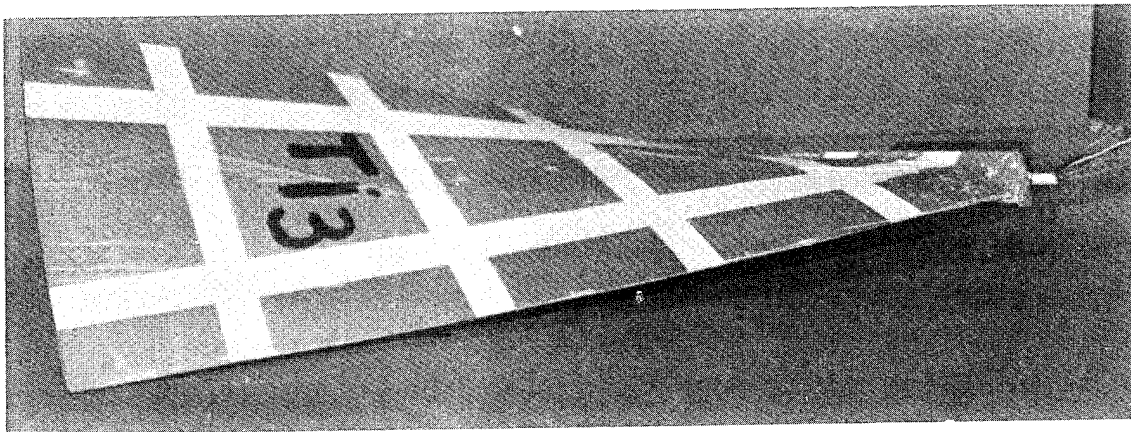
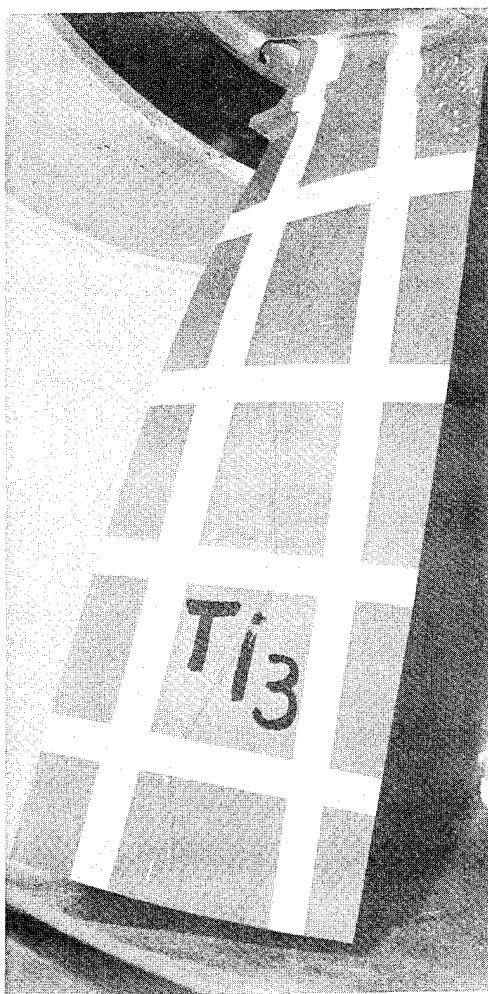
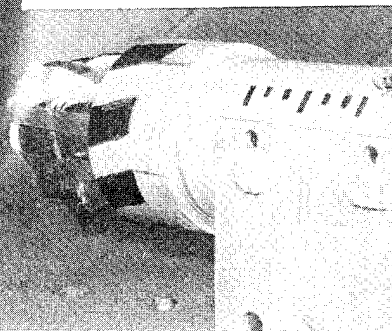
Figure 12. Titanium Blade after Impact.

There was no visible damage to the titanium blade when impacted with an 8 oz bite from a 16 oz pigeon. There was considerable deflection.

NASA-FOD Impact Resistance Test  
 Blade S/N Ti3  
 Titanium  
 Tip Speed: 800 ft/sec  
 16 oz Real Pigeon  
 8 oz Slice  
 22° Incidence Angle

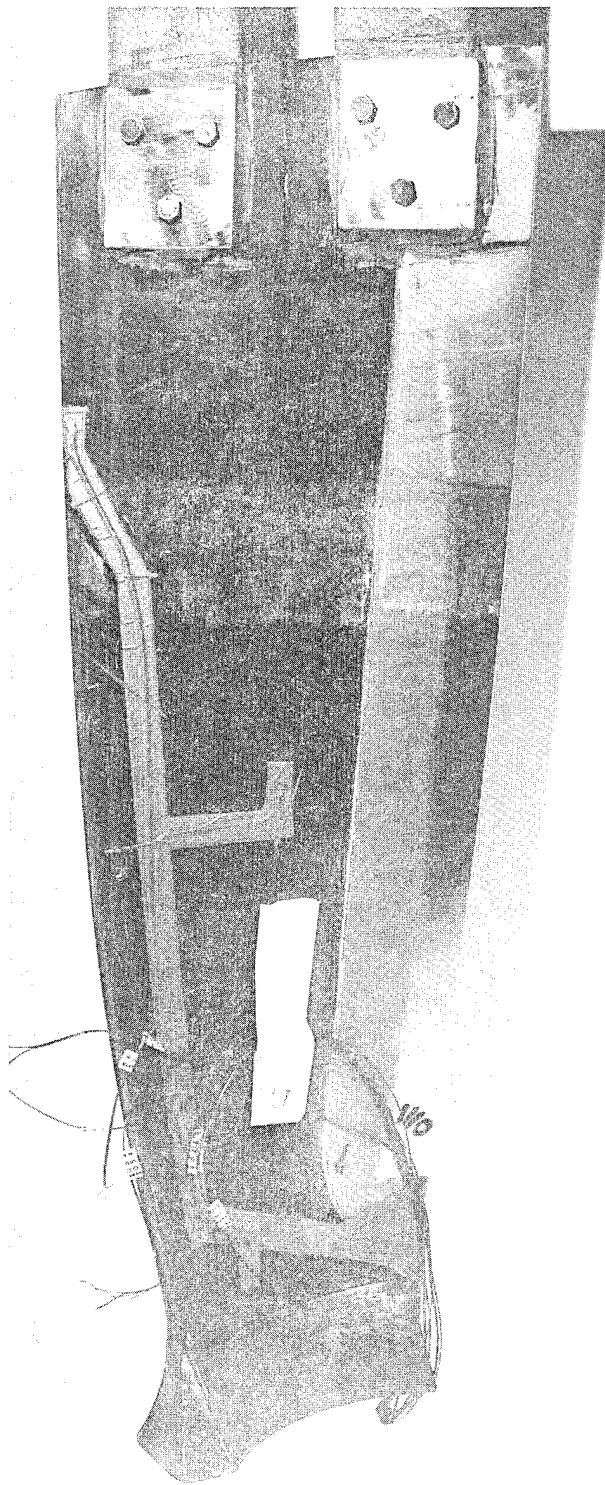
The specimen is shown in Figure 19 (convex view) and 20 (concave view). The only visible damage to the blade was a rather clean crack extending down from the tip section a distance of less than three inches. The chalk coating can still be seen adjacent to the projectile path (Figure 19) which extended across the entire blade chord. The convex surface of the blade was marked only with short line segments extending back from the leading edge. The lines can be seen clear to the leading edge, demonstrating thereby that no projectile interaction has taken place on the convex surface. The axial load measured after the test showed the same level as before the test.

Figure 19. NG5 Graphite/Epoxy Blade  
after Impact (Convex Surface),  
Test No. STOL 1.

Figure 20. NG5 Graphite/Epoxy Blade after Impact (Concave Surface), Test No. STOL 1.

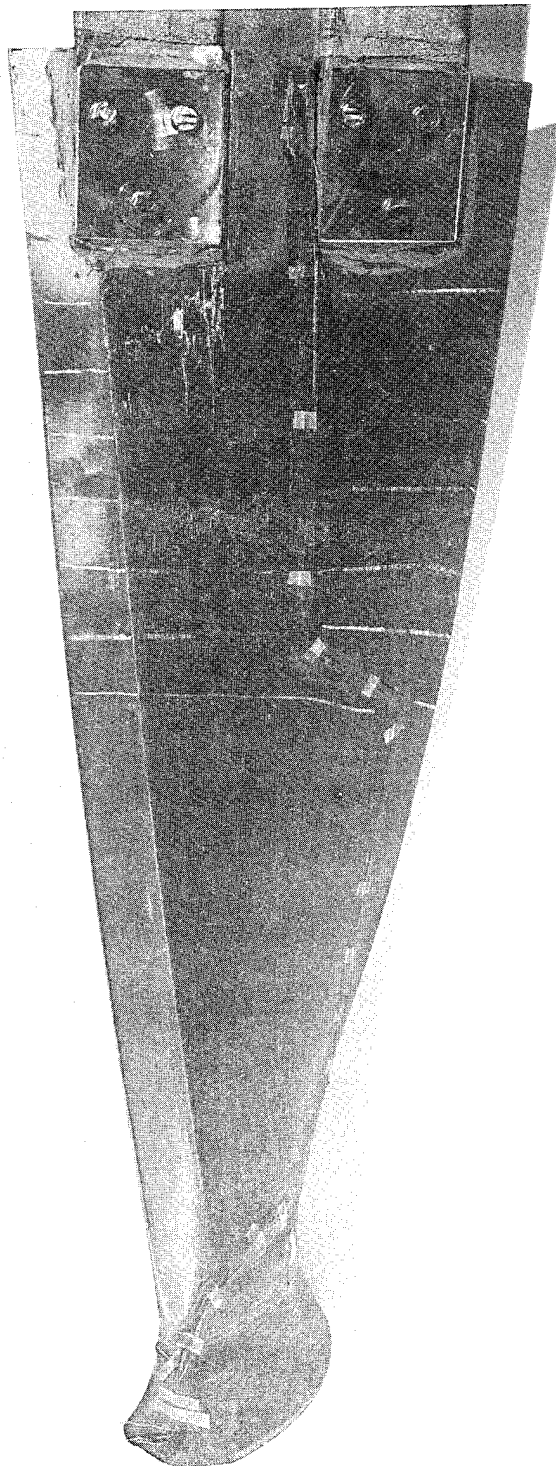
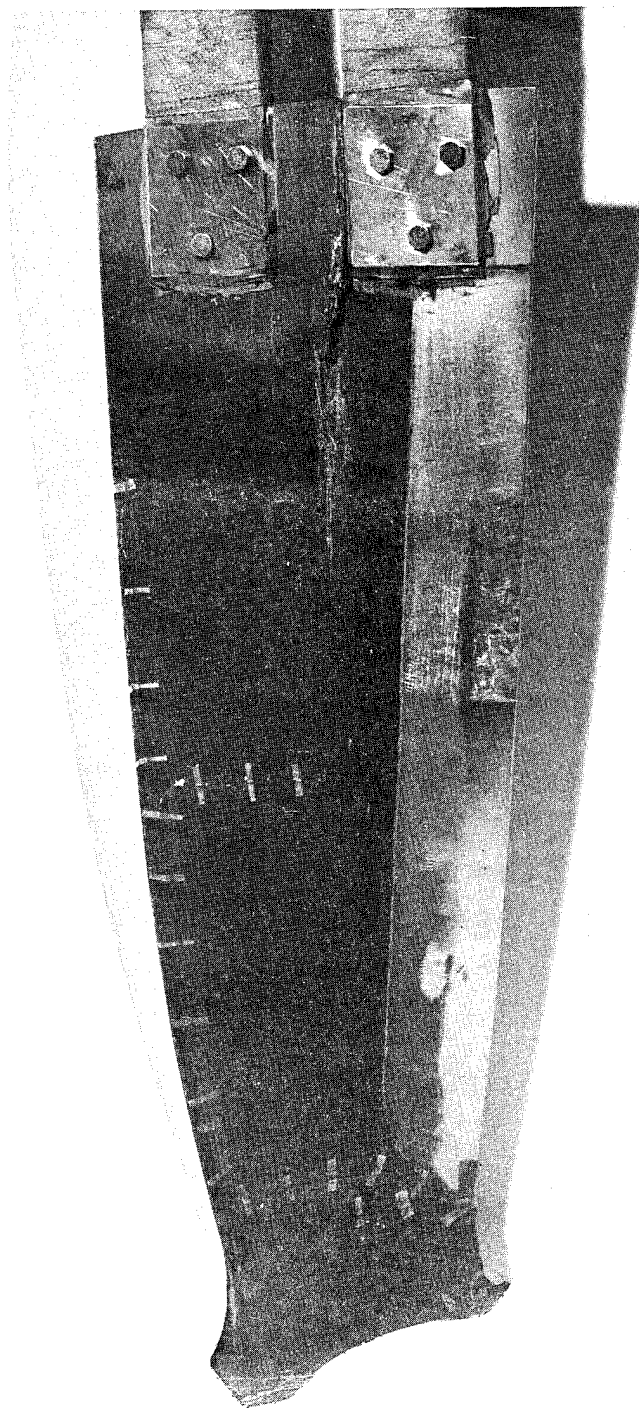
The boron/epoxy blade is shown after impact in Figures 21 (convex) and 22 (concave). This blade was damaged much more severely than the graphite blade. The principal damage consisted of cracks and multiple delaminations extending down from the tip section and situated again between the loading straps. The damage is especially clear in Figure 22. Similar indications of projectile interaction can be seen here as well.

Figure 21. NB5 Boron/Epoxy Blade after  
Impact (Convex Surface), Test  
No. STOL 2.

Figure 22. NB5 Boron/Epoxy Blade after  
Impact (Concave Surface),  
Test No. STOL 2.

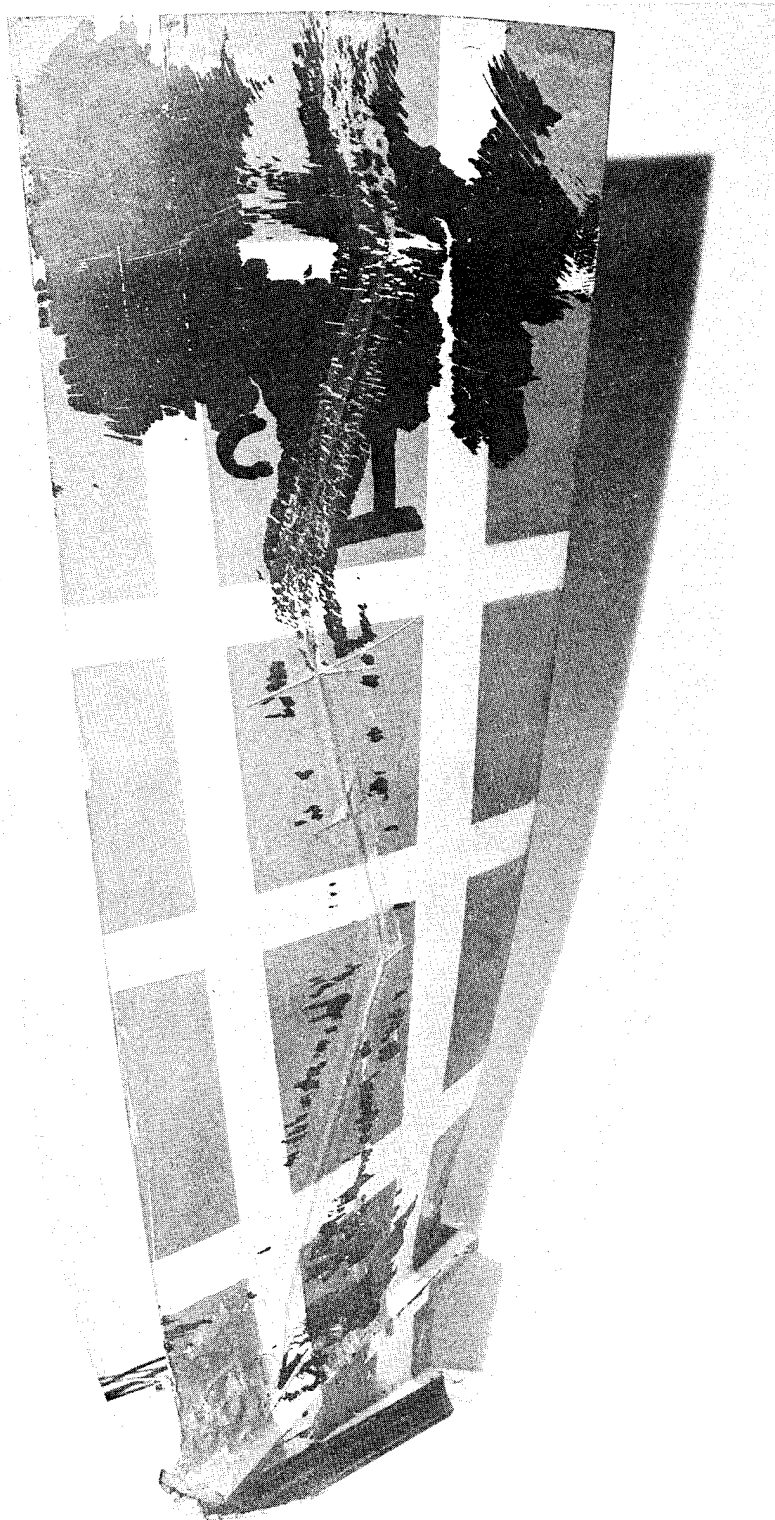
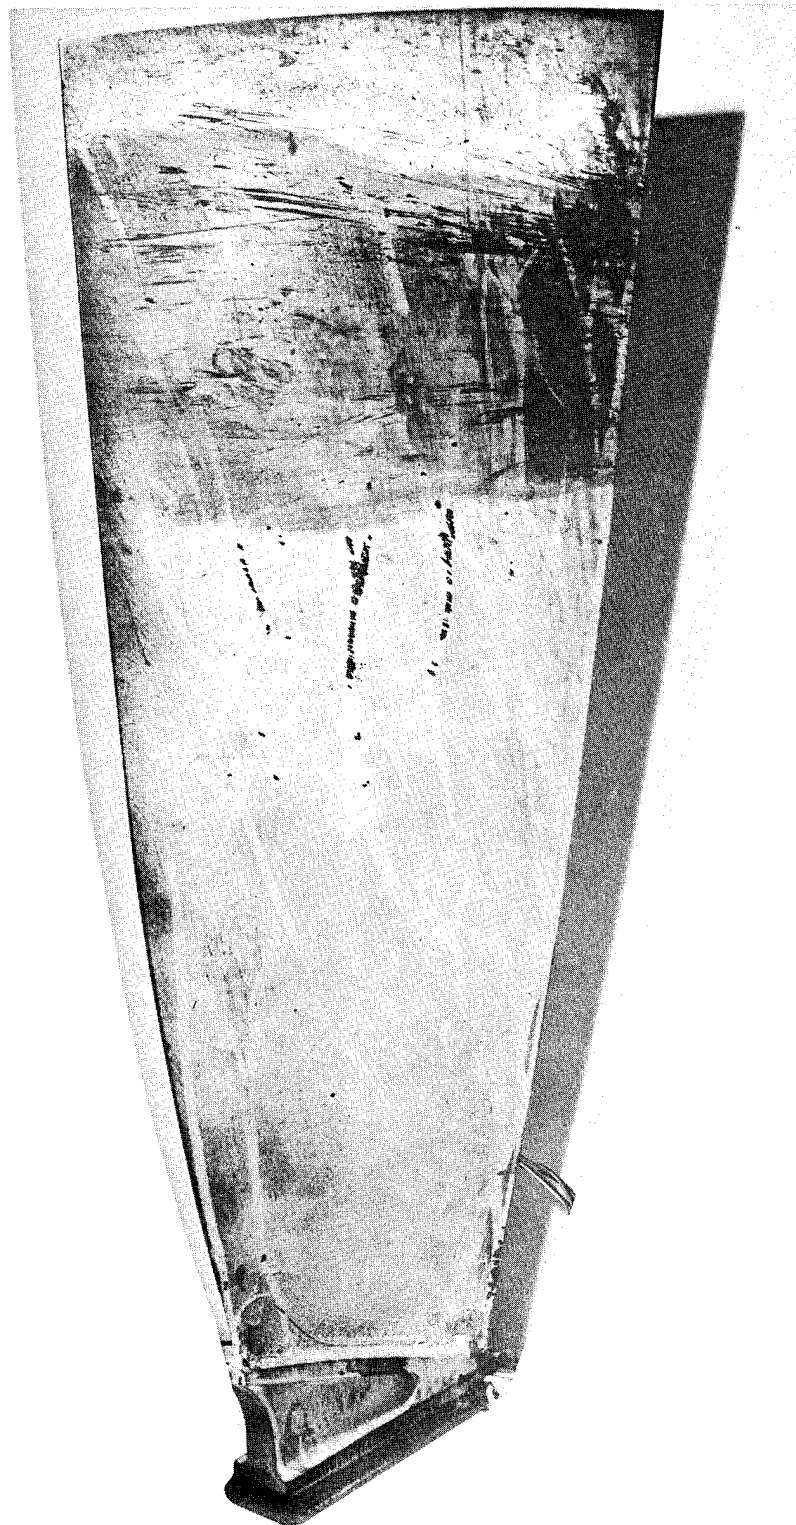
The titanium blade impacted in the third test is shown in Figures 23 (convex) and 24 (concave). The blade was not fractured but was perceptively deformed at the leading and trailing edges along the projectile path.

Figure 23. Titanium Blade after Impact  
(Convex Surface), Test No.  
STOL 3.

Figure 24. Titanium Blade after Impact  
(Concave Surface), Test No.  
STOL 3.
